Nitrogen + Syngas 2016

Return of Experience on the Efficacy and Reliability of Fiber Optic Ammonia Leakage Detection Systems

DANIELE INAUDI, ROBERTO WALDER

SMARTEC SA

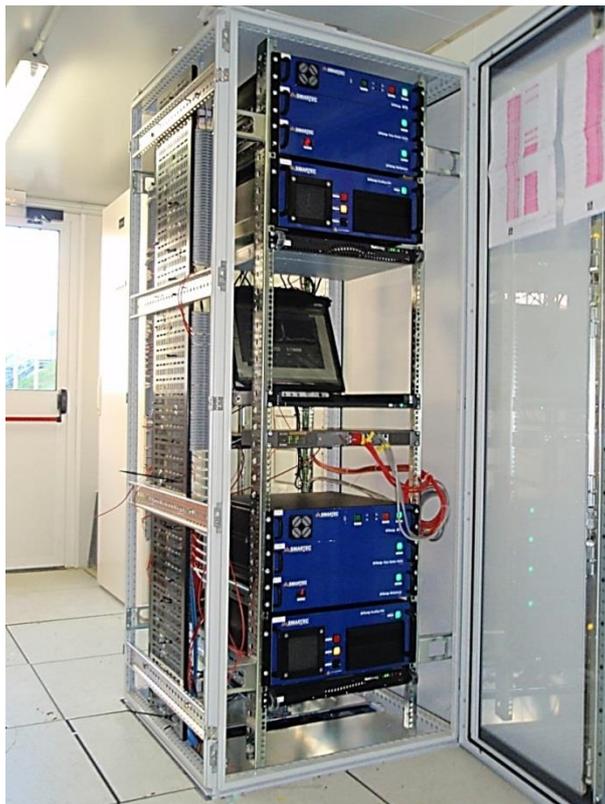
Fig. 1: Fully redundant leak detection system

An example of a rack cabinet containing two fully redundant systems as above-described is shown in Fig. 1, while Fig. 2 shows an example of graphical user interface.

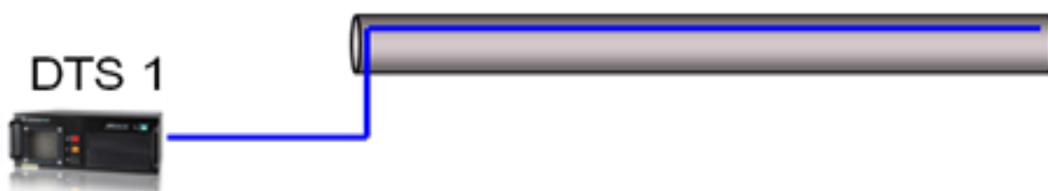
Fig. 3: Example of simple leak detection system with no redundancy

The simplest solution includes a single cable and a single readout system:

One optical cable contains 4 optical fibers and this already presents a minimum redundancy in case of fiber failure. Furthermore, two optical fibers are lopped together at the end of the cable, so that the readings can occur from the two ends of the loop formed by the two fibers. This allows continuing the measurements over the whole length of the pipeline, even in the case of failure of a single fiber.
